Environmental Health Division
401 Harris B. Dates Drive, Ithaca, NY 14850
(607) 274-6688; Fax (607) 274-6695

Preliminary Report August 12, 2004 Investigation of Hunt Hill/Midline Road well microbiological contamination

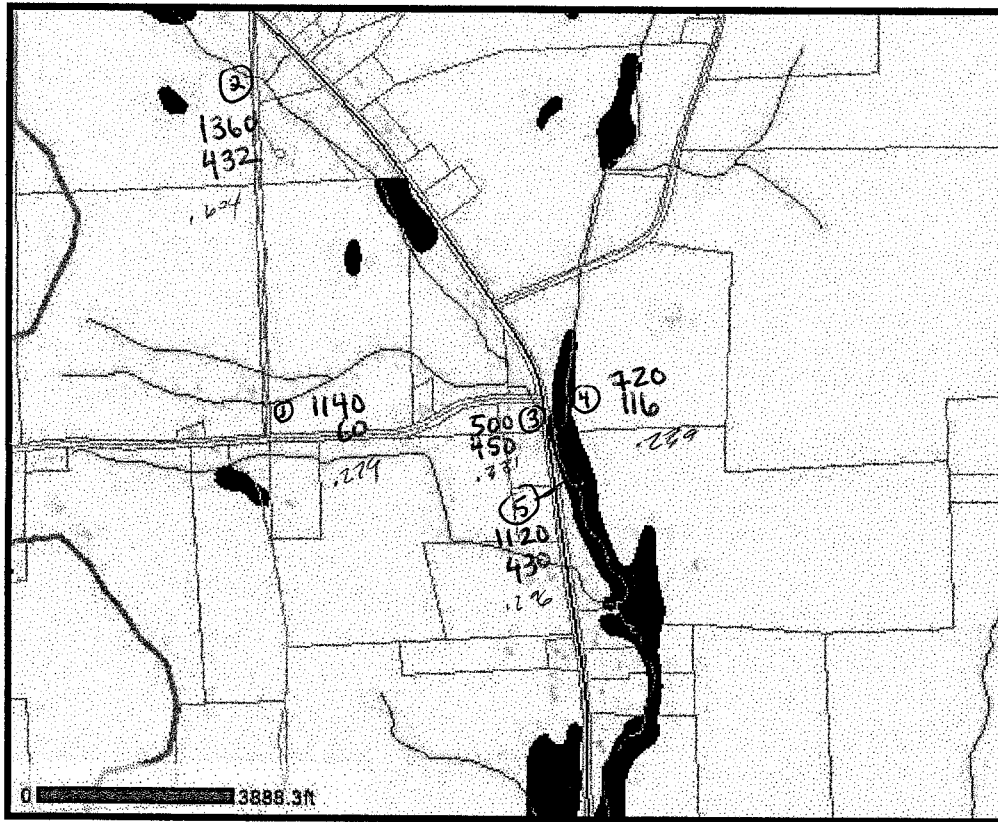
Attachment 3: Location and results of stream water samples

- Five samples of the streams, from Cornelius Road to opposite 730 Midline Road, showed only small differences between the sites for Nitrogen, Total Coliform and Fecal Coliform. The Nitrogen levels were all <1 mg/l, the Total Coliform <1500 /100ml, and the Fecal Coliform <200/100ml at two sites and <500 at three sites. (The Standards are 10 mg/l, 2400/100ml, and 200/100ml. The microbiological standards are based on 5 samples in a month, so the single sample does not indicate a violation of standards nor a gross contamination.)

total coliform /100 ml
 fecal coliform /100 ml
 Nitrate as N, mg/l

Samples Collected 7/22/04 by TCRD
